## Case History: Pulp & Paper Plant Cooling Line Renewal

*Leaking 54”  
Raw Water  
Cooling Line  
Relined and  
Returned to  
Service in  
Just 3 Days!*

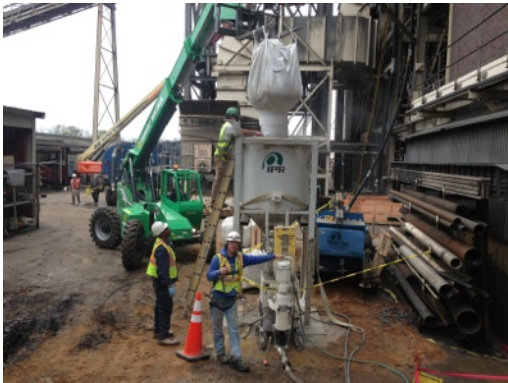
A 54” cooling line, lying beneath this IPR Industrial EcoCast crew, was leaking into a 13,500 kV room shown on the right side of this photo.

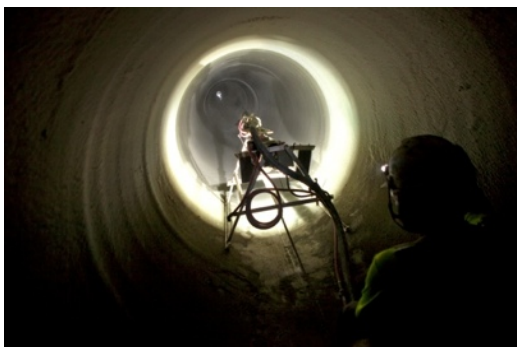
The EcoCast system was lowered into the deteriorated 320 ft. line from a man-way and relined it with a structural and corrosion resistant geopolymer. The line renewal took only 3 days to complete.

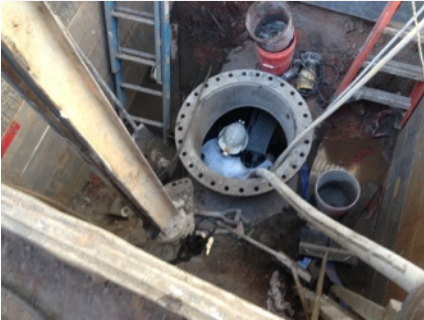
A 30" man-way was cut into the cooling line to gain access.

To gain entry into the line, the ground was excavated to top of the pipe. A man-way hole was then cut into the pipe's upstream end to lower the EcoCast sled and crew into the line. Once inside the pipe, IPR Industrial crews cleaned the line with a high pressure washer and applied GeoFuse, which is a bonding agent for the EcoCast lining material.

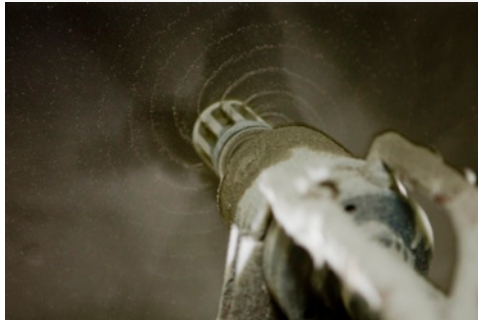
The EcoCast spray applicator spins at 5000 RPM when applying GeoSpray to the line's surface.

Once the EcoCast sled and mounted spray head were in position, the GeoSpray application process began. Traveling at roughly 1 ft. per minute, with the head spinning at 5,000 rpm, the material was applied at the max thickness of 1/2 in. per pass. It should be noted that GeoSpray's curing process begins as soon as it makes contact with the pipe. For this project, the IPR Industrial crews applied three coats. After the final pass, the old water line was not only leak free, but structurally restored, as well. The entire procedure took less than three days. The EcoCast lining was then inspected for defects and a proper cure. Given the green light, the IPR Industrial crews repaired the man-way hole with a bolt-on blind flange, the line was pressure tested then approved to be brought back on line.

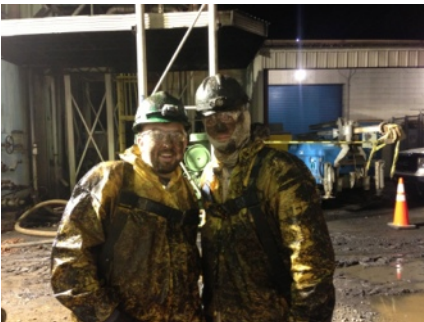
IPR Industrial personnel worked round the clock, in shifts, to complete the cleaning, prepping, and restoration of the leaking 320 ft. cooling line.
